Designation Statement

Clytha Conservation Area

June 1999

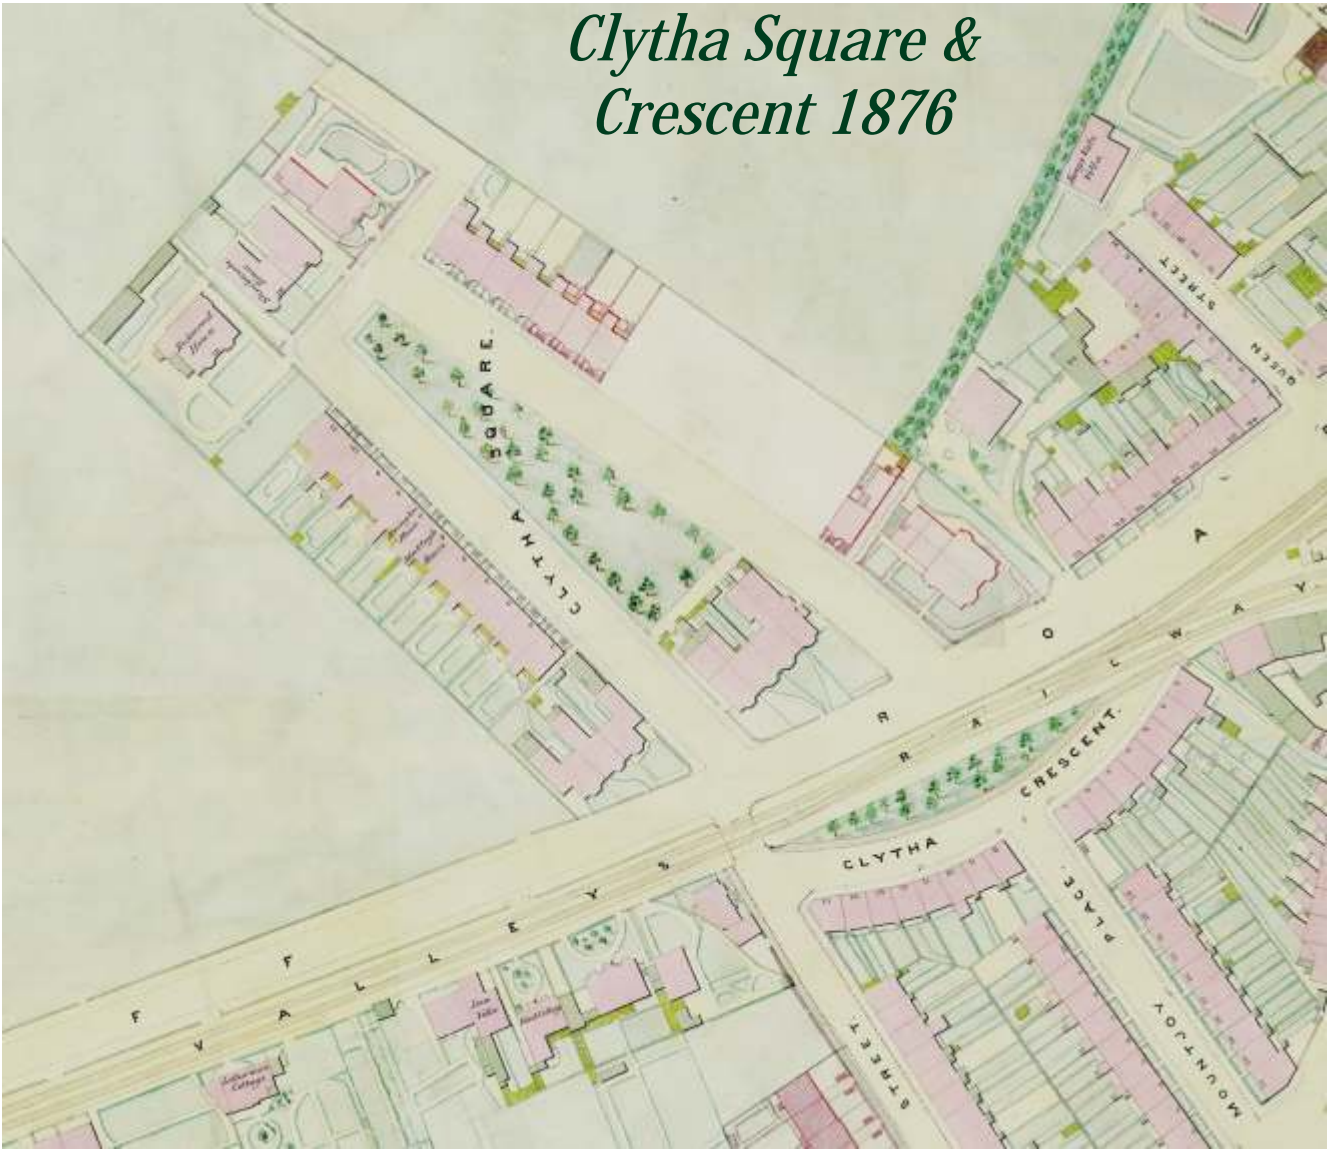
Clytha Square & Crescent 1876

The Clytha conservation area is composed of two distinctive areas of contemporary Victorian housing straddling Cardiff Road. Clytha Square and Crescent compose a neighbourhood of planned development dating from the third quarter of the nineteenth century. The continuous terraced development of three stories framing the southern and northern sides of Clytha Square were constructed between 1870 and 1880. Clytha Crescent on the south-eastern side of Cardiff Road also dates from the early 1870's. No reference is made to the Square or Crescent in the 1861 census, the first references appearing in 1871. A plan of the Square and Crescent survives from 1876. By that date the Square and Crescent have assumed their existing form, with properties in the northern side of the Square still under construction.

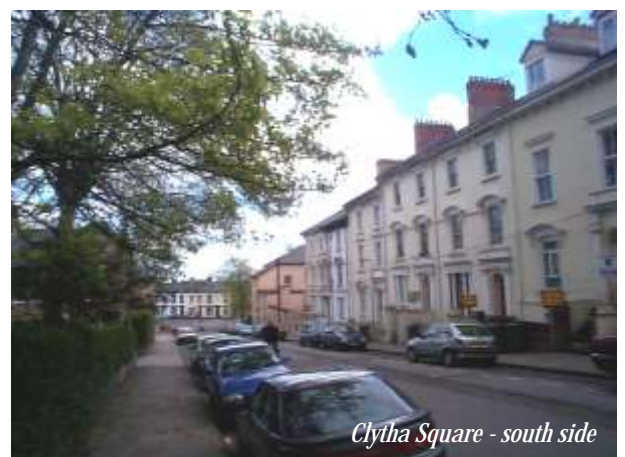
Clytha Square - south side

Historic social hierarchy. The most elaborate detailing survives on the southern terrace which is probably the earliest housing in the conservation area (Ca1870) with hornless four paned sashes (some with arched heads) and a variety of original two and four-panelled doors. The northern terrace and Cardiff Road frontage which is composed of semi-detached and short runs of terraced

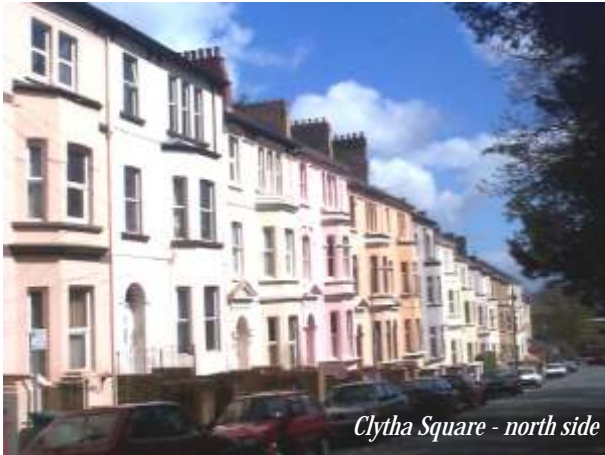
Clytha Square - north side

mid-nineteenth century, three-storey housing, (enclosing the eastern end of the Square) similarly retain raised architraves, platbands and bracketed eaves. In contrast to the southern terrace, these properties have canted bays extending to second floor level, with parapet detail. Window and door openings are emphasised by the use of projecting reeded, flat and segmental hood details.

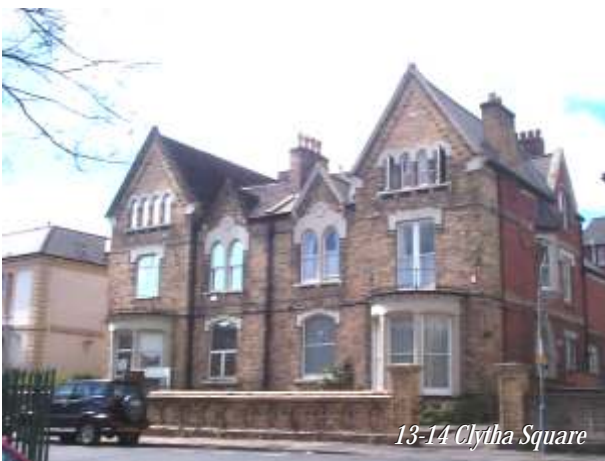
13-14 Clytha Square

Whilst the Square is dominated and defined in character by the classically-derived, stuccoed Italianate Victorian terracing on the north and south sides, the stylistic transition in the later Victorian period towards Gothic and Freestyle is manifested at the western end of the Square. Numbers 13-14 comprise a pair of yellow brick villas in a Gothic derived idiom with Bathstone window surrounds and steeply pitched gabled roofs. Whilst adjacent to this pair is number 12, the finest detached Italianate villa in the Square. Both developments were complete by 1876. This property has suffered from the removal of the eaves brackets and chimney stacks. At the eastern end of the Square to the rear of properties fronting Cardiff Road a semi-detached pair of late Victorian, weakly Italianate brick villas have been introduced. These properties are not indicated as plots on the 1876 plan, instead their plots form part of the sylvan glade planting at the centre of the square. Whilst the infilling of this important space is regrettable, such development may illustrate the declining social status of

the Square in the later Victorian period. These properties do provide a useful screen to the rear elevations of the Cardiff Road frontage and have largely escaped external alteration.

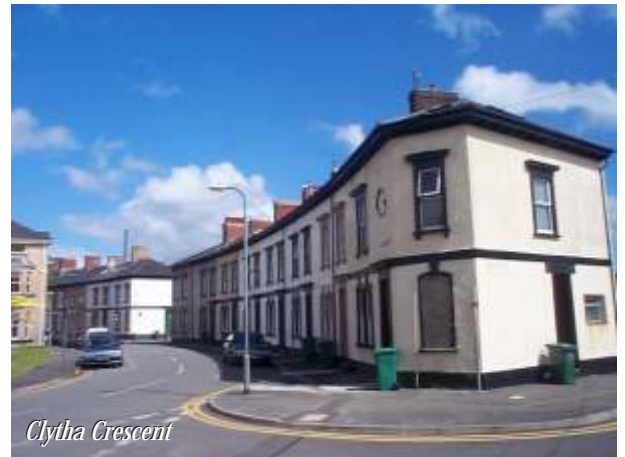
Clytha Crescent

The two segmental terraces of eight houses forming the eastern side of Clytha Crescent, are more subdued in character in comparison with properties on the western side of Cardiff Road. Their two-storey scale and more modest detailing reflects their lesser social status. Each unit has two six paned sashes at first floor level set within a render architrave with a projecting reeded hood over. At ground floor level are a coupled pair of flatly arch headed, four-paned sashes also set within a rendered

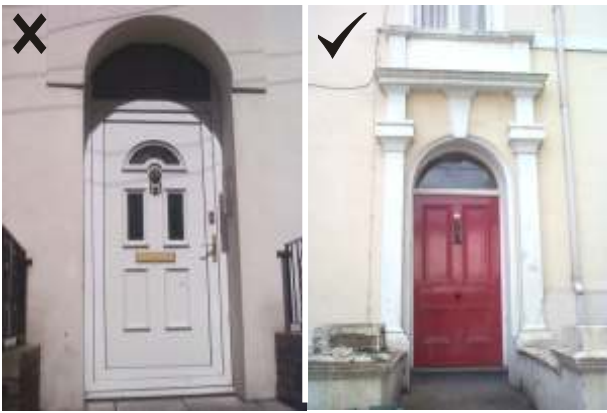
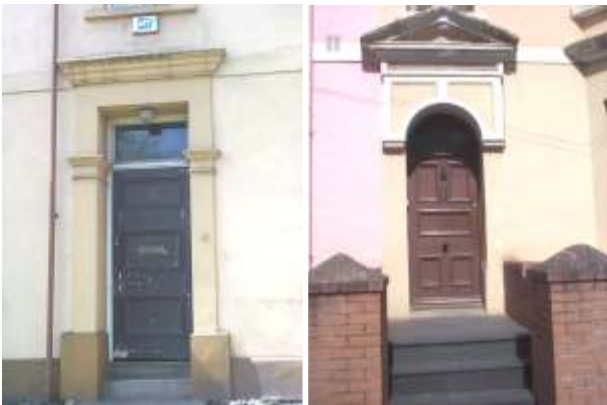
Historic Joinery should always be respected and retained as an important element of period detail, which lends the conservation area its distinctive character. Within the Square and Crescent a variety of panelled doors survive. Surviving doors should always be repaired and not replaced by inferior modern alternatives. Where doors

have been lost, it is strongly recommended that a copy is made of a historic door in the locality. Grant aid from the County Borough may be available to subsidise the cost of replacement joinery.

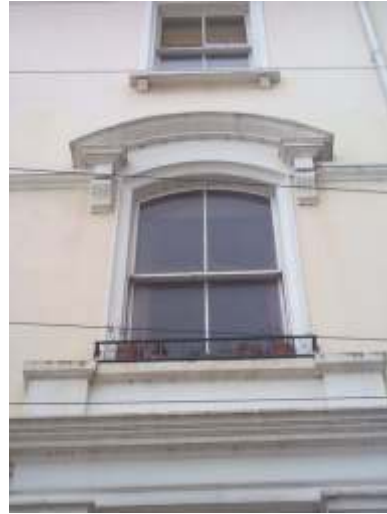
Sash windows are exclusively found throughout the conservation area. The original sashes are hornless and may be two, four or six paned. It is important that

surviving sashes are retained, repaired and refurbished and not replaced by crude modern approximations. UPVC windows are entirely inappropriate to the special character of the conservation area. Where windows have been lost and replaced by inappropriate alternatives, their replacement by an appropriate sash type is encouraged. Grant assistance may be available to encourage the repair and reinstatement of sashes.

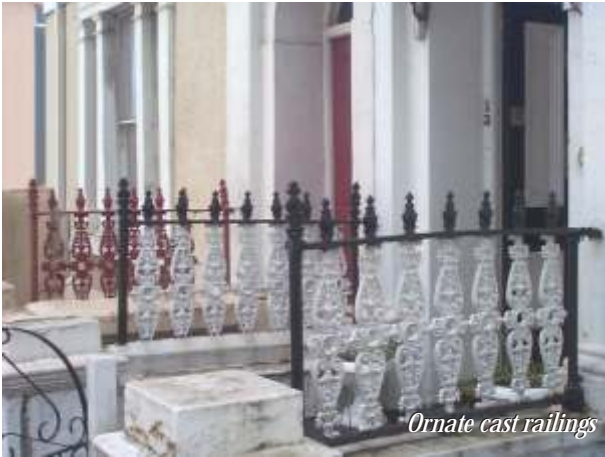
Ornate cast railings

Boundary walls and railings are part of the cherished streetscene and should always be retained and repaired. Within the conservation area is a variety of different walling; including exposed natural stonework, stucco and buff brickwork. Decorative cast and wrought iron railings add a distinctive element within the streetscene. The repair or reinstatement of railings and boundary walling may be eligible for grant assistance from the County Borough.

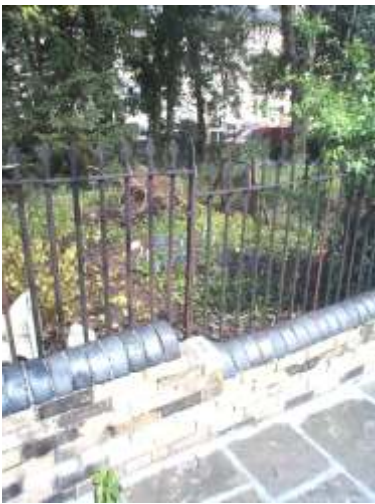
Simple spiked wrought iron railings

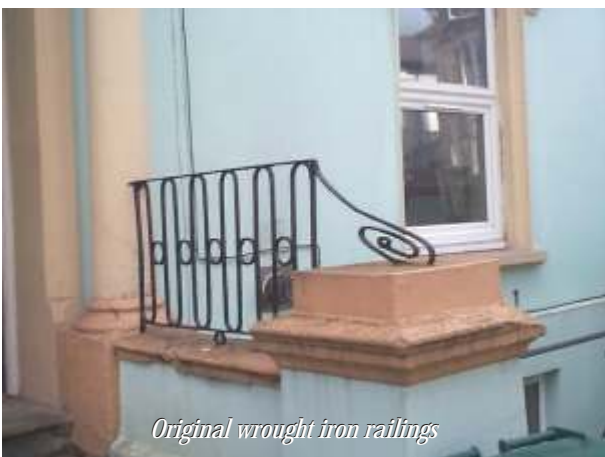
Original wrought iron railings

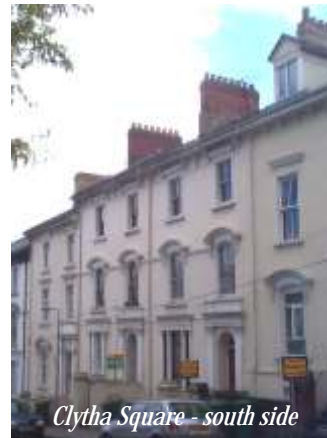
Clytha Square - south side

The consistent use of natural slate roofing serves to unify the conservation area. The roofscape is punctuated by substantial multiple-flued chimney stacks with a variety of pots. On the southern side of the Square are a series of

later pedimented dormers, which have been disfigured by modifications. Such dormer windows are not to be encouraged as they disrupt the shallow pitched roofs of the Italianate properties. The removal of incongruous mutilated dormers is to be encouraged. Where fenestration is essential
